SWORN AFFIDAVIT

Re: Vernell B. Morris Case

The following is a summary of the activities and results to date in the reconstruction of the September 02, 2004 accident involving Vernel B. Morris, driving a 1998 Kenworth tractor and Edward N. Thompson, driving a 1995 Peterbilt tractor. The accident occurred on Interstate 85 northbound, between Macon County Road 30 and Macon County Road 93, in Macon County, Alabama.

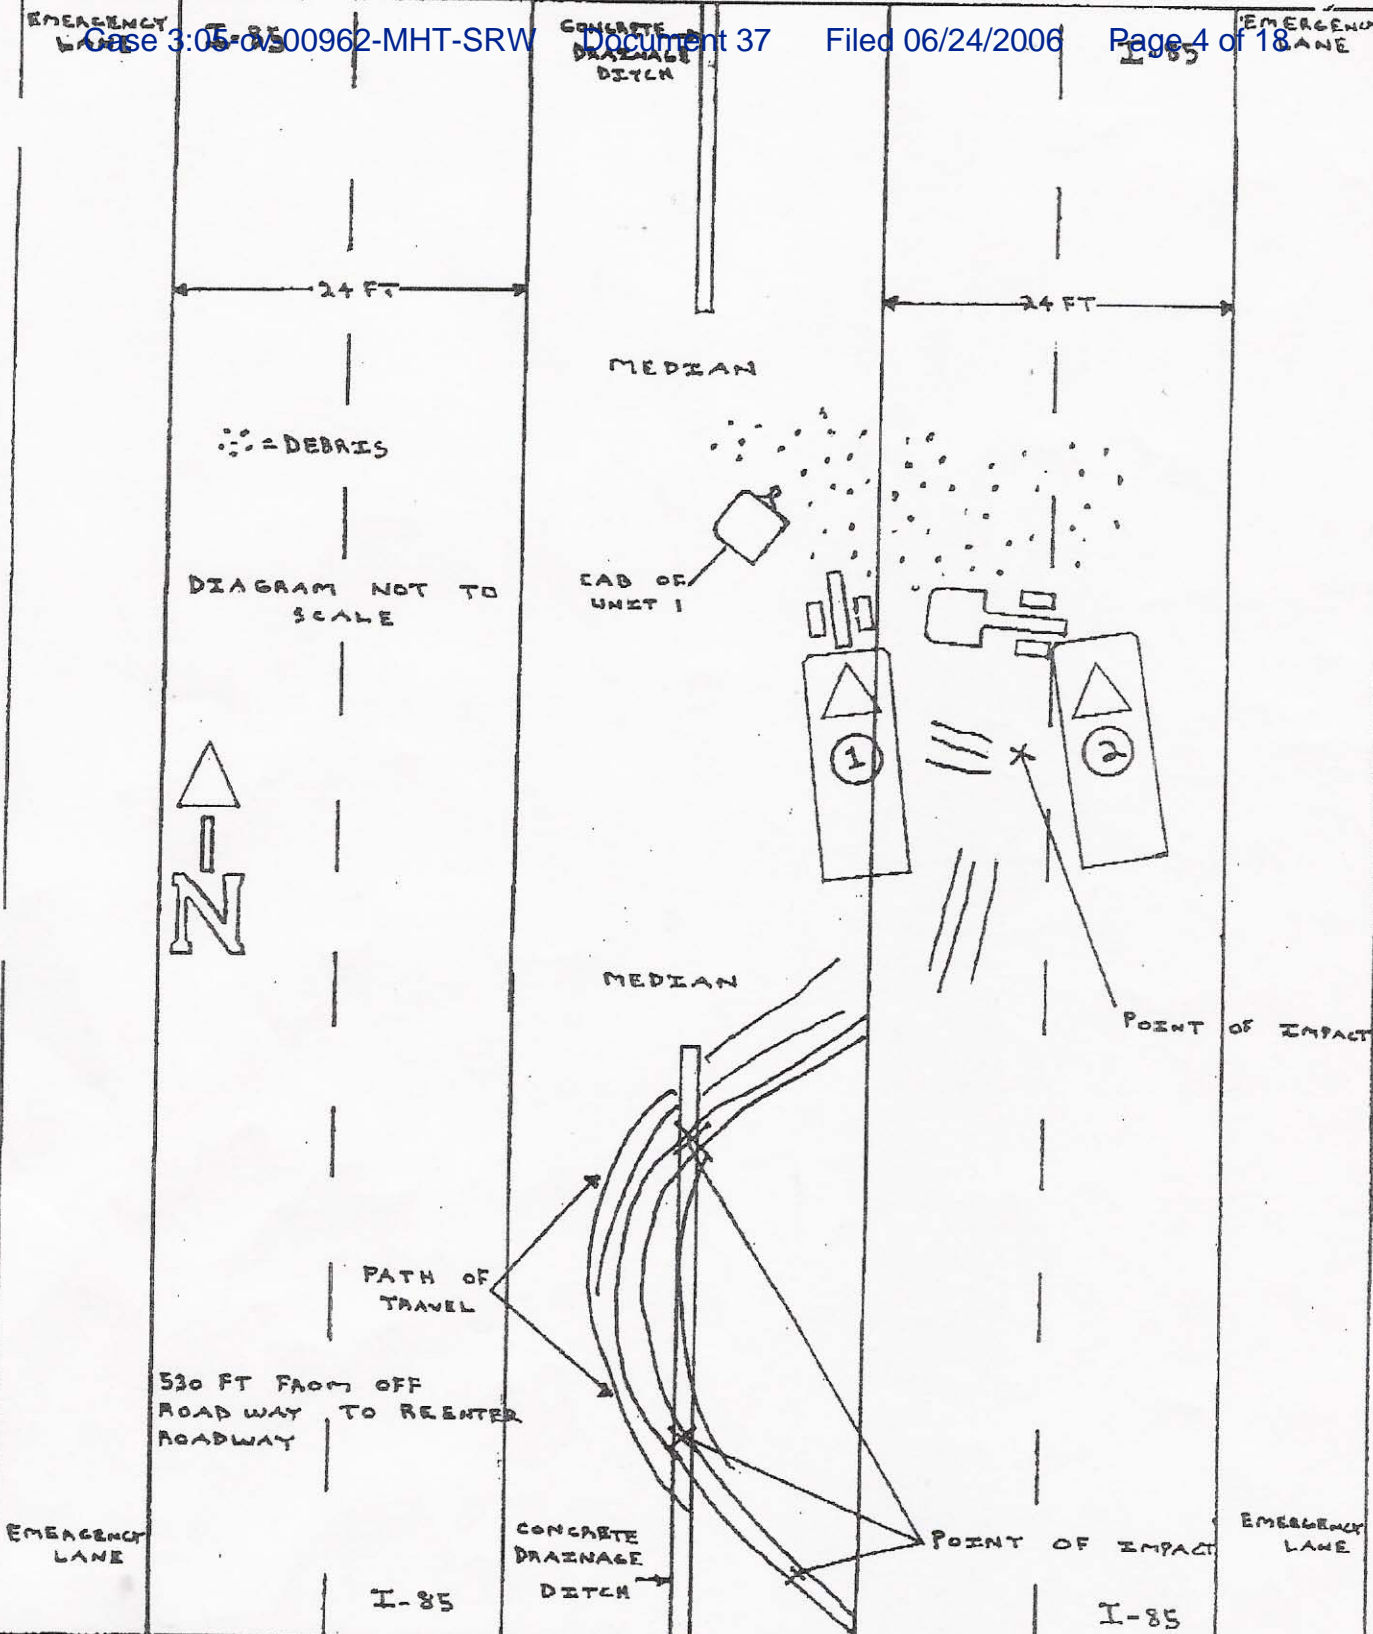
DESCRIBE WHAT HAPPENED (Refer to vehicles by number) UNIT 1 WAS TRAVELING NORTHBOUND ON I-85. UNIT 1 LEFT THE LEFT SIDE OF THE ROADWAY, WENT DOWN AN EMBANKMENT, STRUCK A ROAD SIGN, STRUCK A DRAINAGE DITCH, WENT UP AN EMBANKMENT, CAME DOWN AN EMBANKMENT, STRUCK A DRAINAGE DITCH, WENT UP AN EMBANKMENT, OVERTURNED ON THE DRIVER'S SIDE, CAME BACK ONTO THE ROADWAY BLOCKING BOTH LANES OF NORTHBOUND I-85, AND IS STRUCK BY UNIT 2 TRAVELING NORTHBOUND ON I-85. AT THE TIME OF THE COLLISION DRIVER OF UNIT 2 ADVISED HE WAS UNABLE TO SEE UNIT 1 IN THE ROADWAY. INVESTIGATION REVEALED THAT AT THE TIME OF THE COLLISION DUE TO THE POSITIONING OF UNIT 1 UPON COMING BACK ONTO THE ROADWAY THE BOTTOM OF THE UNDERCARRIAGE WAS THE ONLY PART OF THE VEHICLE THAT COULD HAVE BEEN SEEN BY THE DRIVER OF UNIT 2. UNIT 1 WAS FURTHER TRANSPORTING TITANIUM DIOXIDE IN DRY BULK FORM. THERE WERE 22 PALLETS OF TITANIUM DIOXIDE R101-04 WITH A WEIGHT OF 2000 POUNDS EACH. THE FREIGHT WAS BEING DELIVERED TO THE STANDRIDGE COLOR CORPORATION IN SOCIAL CIRCLE GEORGIA. NONE OF THE MATERIAL WAS SPILLED NOR WERE ANY OF THE PACKAGES RUPTURED OR DAMAGED. THE MATERIAL REQUIRED PROPER HANDLING AND STORAGE DUE TO ITS POTENTIAL TO BECOME HAZARDOUS. ALL HANDLING AND STORAGE WAS DONE BY THROWER'S WRECKER SERVICE.

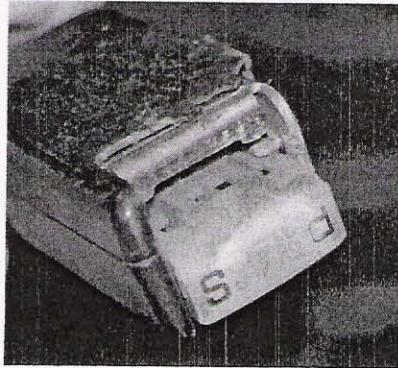
This determination was made from an examination of the safety belt latch, the driver seat, and the safety belt. Photo #1 depicts the latch mechanism from the seatbelt, which was more probably than not destroyed from the force exerted on the belt due to the collision between the two trucks. The seatbelt latch is on the driver's right, and the vehicle rolled onto the driver's left. This strongly indicates that it is more probable than not, that damage resulted from the collision force between the trucks, rather than simply breaking due to the nearly static stress on the belt when the vehicle rolled.

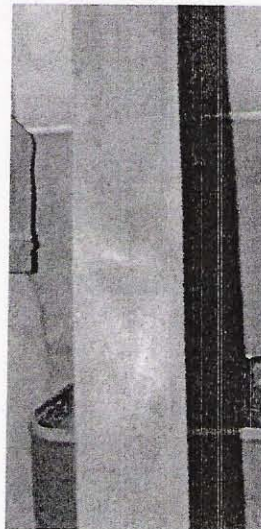
In addition to the latch, the seatbelt itself showed obvious signs of excessive loading, or force being applied to the belt that stretched it. Photo #2 shows the shiny areas where the belt was stretched and rubbed by the latch plate. Moreover, the seatbelt was locked in an extended position, not the rewound position, showing that it was more probably than not being worn at the time of the most severe impact.

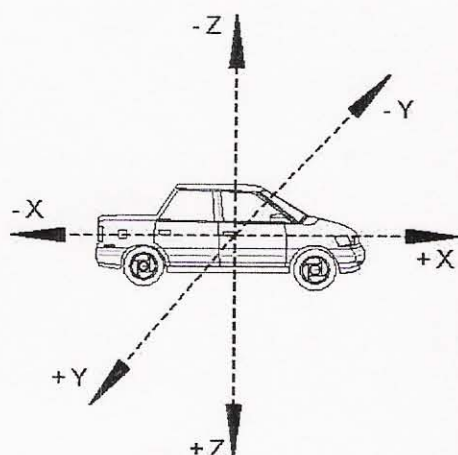
Upon inspection of the cab of the 1998 Kenworth, the driver seat was observed to be pushed up (from the floor) and forward toward the steering wheel, that is, deformation was experienced along the negative z axis (upwards, relative to the normal upright position of the truck) and along the positive x-axis (the normal forward direction of travel), and also along the negative y-axis (toward the left, or driver side of the truck). Photo #3 depicts the position of the driver seat when it was inspected, and a Cartesian coordinate system for reference.

The position of the seat and the fact that the deformation is most severe in the negative z and positive x directions shows clearly that the deformation is undoubtedly the result of the collision between the two trucks, not the result of the rollover experienced by the Kenworth just prior to the collision. The position of the seat corresponds to the pattern of injury documented by the Alabama Department of Forensic Sciences. According to the Autopsy Report, bruising was located at the anterior chest wall and lower abdominal wall, fractures of ribs #1-5 on the right, and ribs #1-7 on the left. Also noted was a lacerated spleen and bruising to the left arm and shoulder. These injuries are consistent with the belted driver being in the seat when the vehicle collision occurred. It therefore appears more probable than not that Mr. Morris would have been alive until the occurrence of the very severe impact that knocked the cab of the Kenworth tractor off its frame.
